Innovative small-scale BGI for storm water management in the inner city

Rainwater tank and Permeable surface

Rainwater tank and permeable surface built on the premises of the Stanisław Staszic High School No. XI in Radom.

LIFE14 CCA/EN/000101 LIFERADOMKLIMA-EN

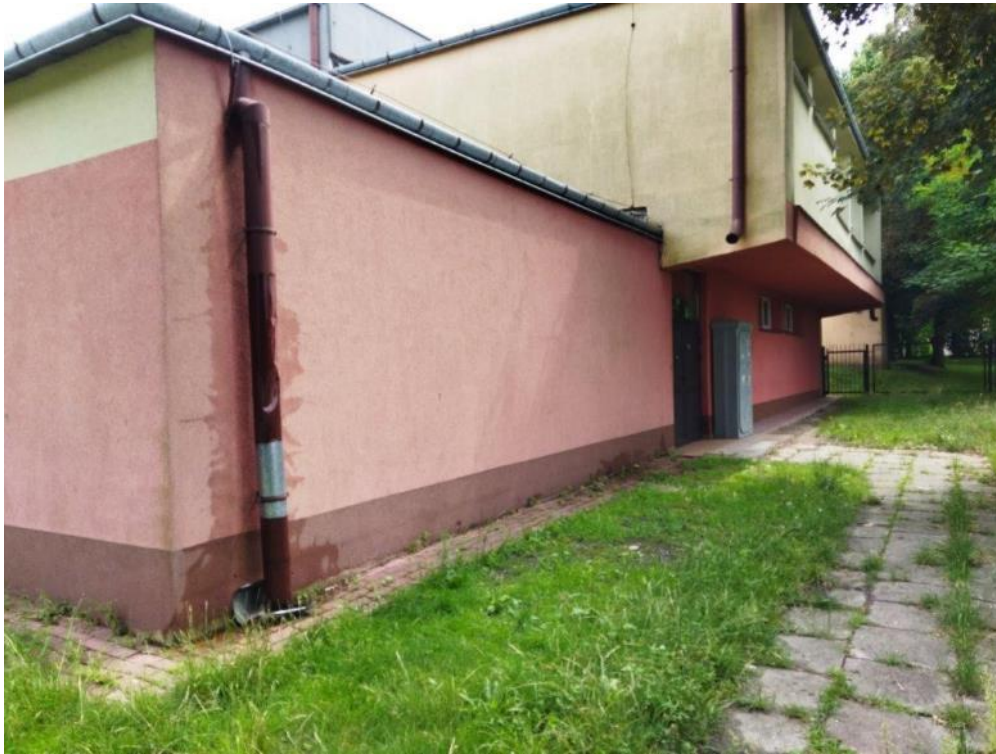
Photo 1 Appearance of the site before construction - Rainwater tank and Permeable surface

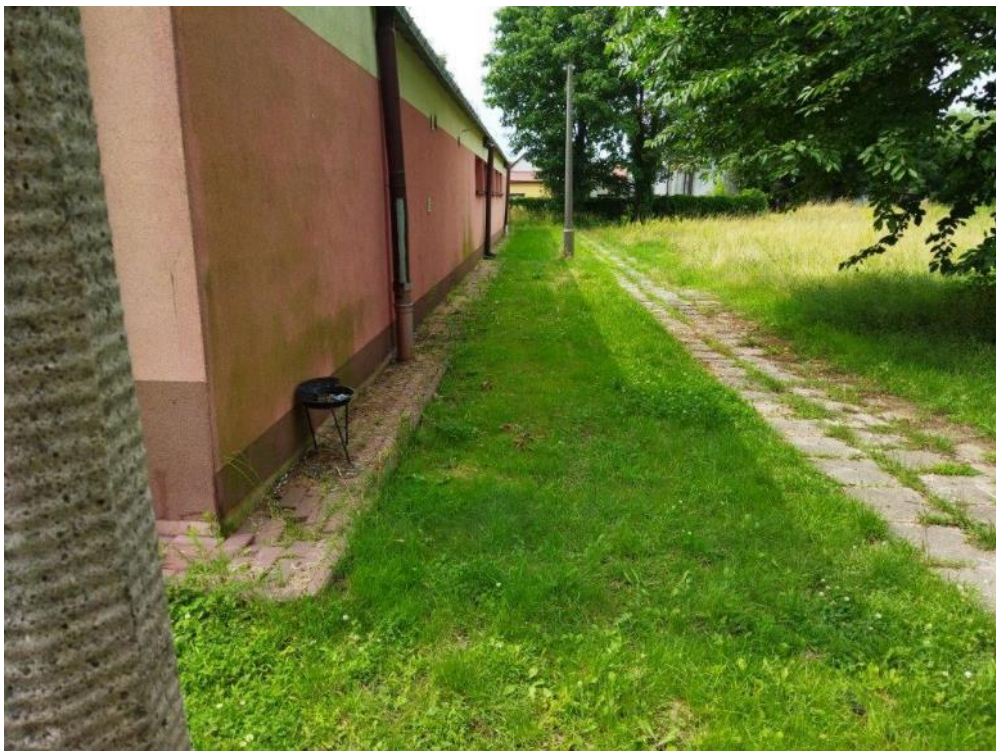
Photo 2 Appearance of the site before construction - Permeable surface

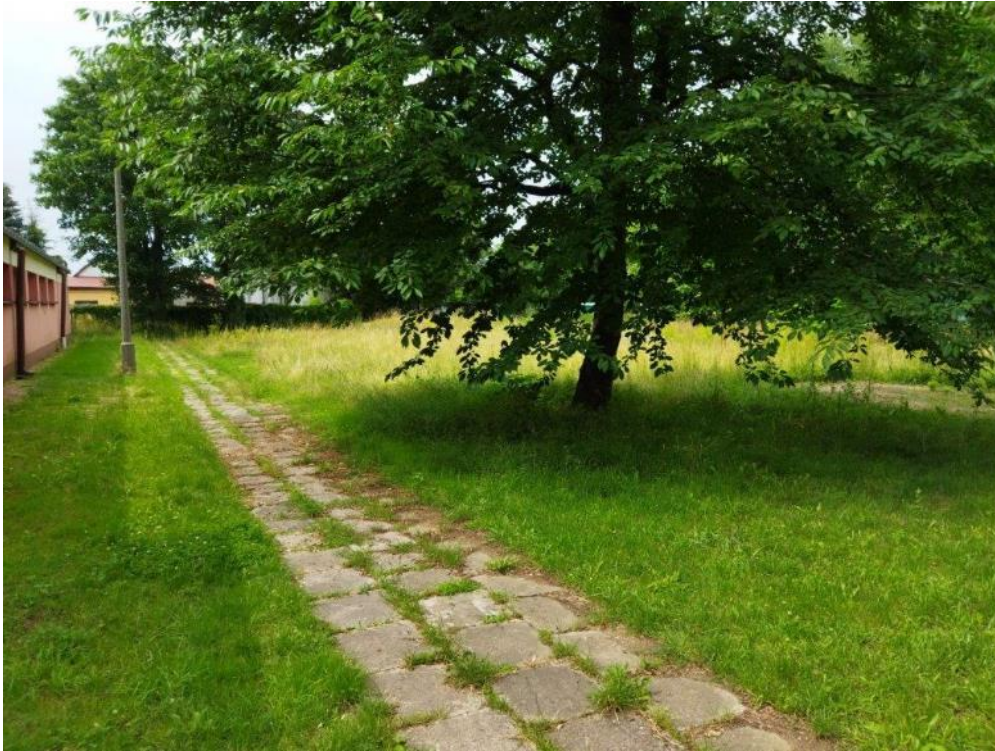
Photo 3 Appearance of the site before construction - Permeable surface

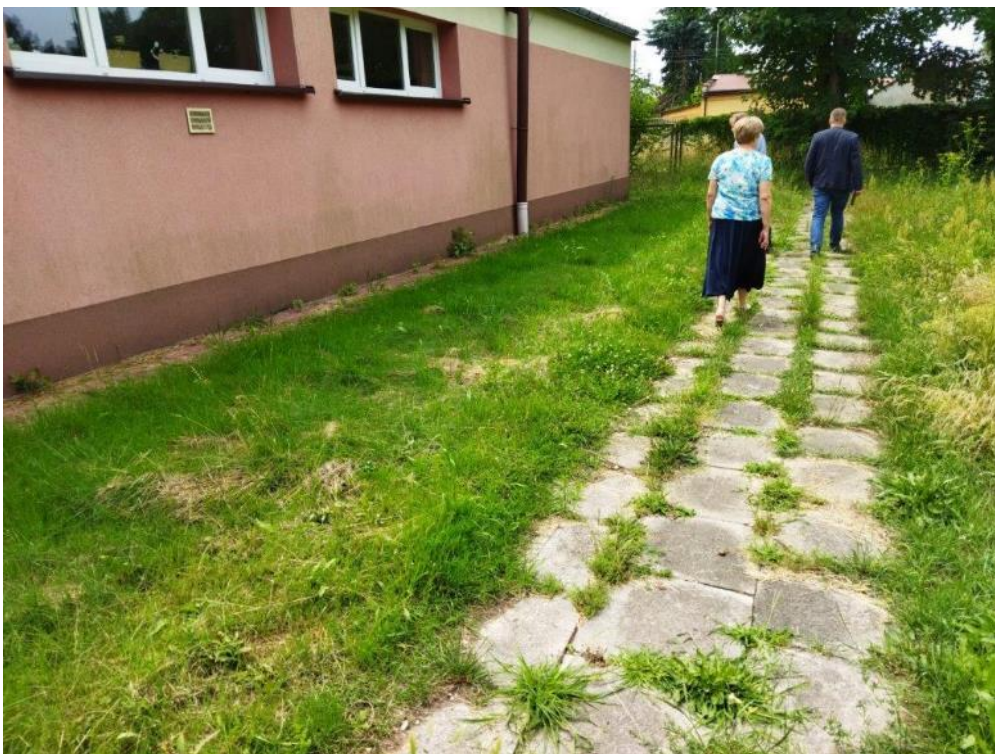
Photo 4 Appearance of the site before construction - Permeable surface

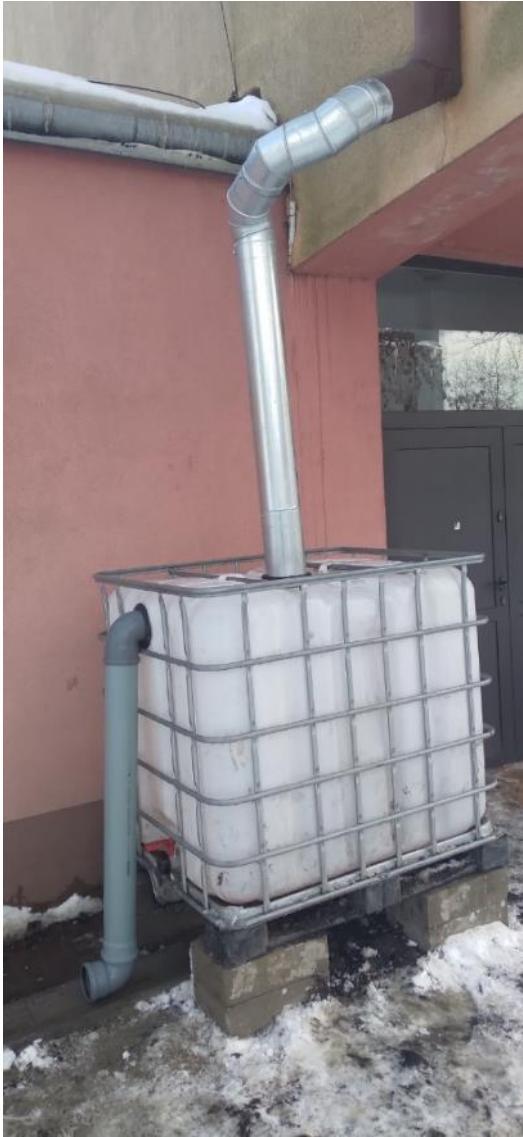
Photo 5 Appearance of the area after construction – rainwater tank

Rainwater tank – 1000 l tank collecting rainwater from the roof of Stanisław Staszic Highschool No. XI.

The tank has a water collection system that will be used to irrigate the nearby community garden. Overflow water will be discharged through dry streams into Climapond.

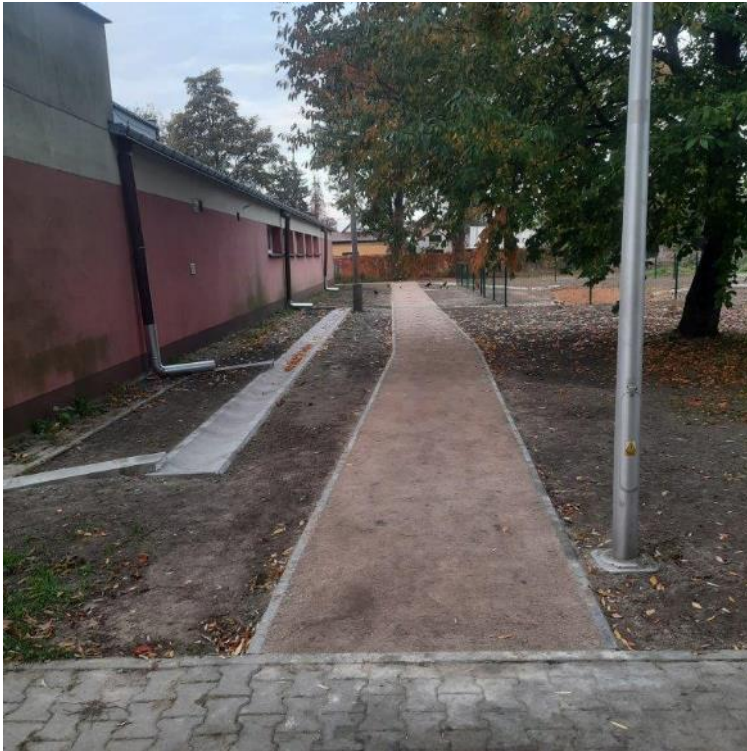
Photo 6 Appearance of the site after construction – Permeable surface

Permeable surface - on the premises of the Stanisław Staszic High School No. XI in Radom, approx. 65 m² of pavement made of concrete slabs has been replaced with a demonstration permeable surface. A special mineral mixture was used to allow rainwater infiltration into groundwater.

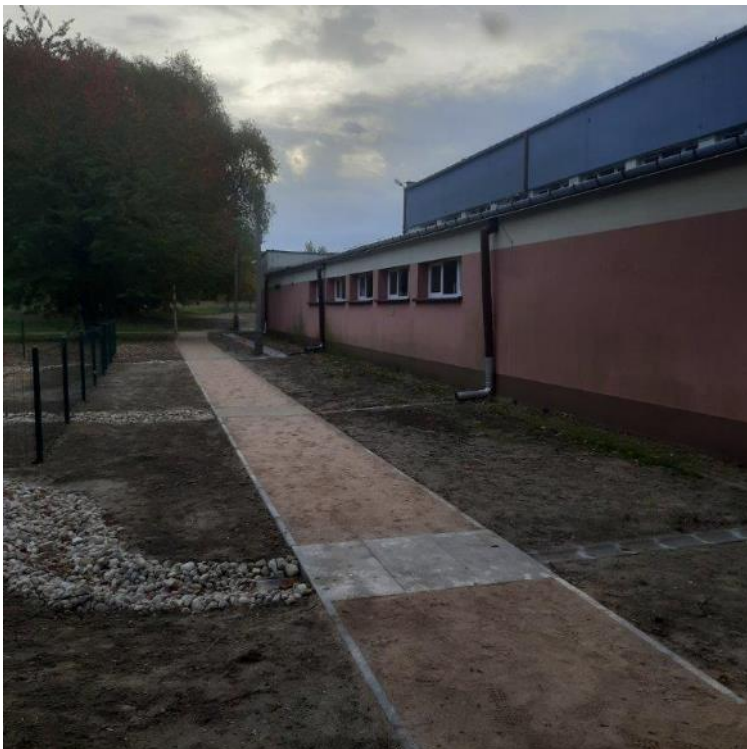
Photo 7 Appearance of the site after construction – Permeable surface

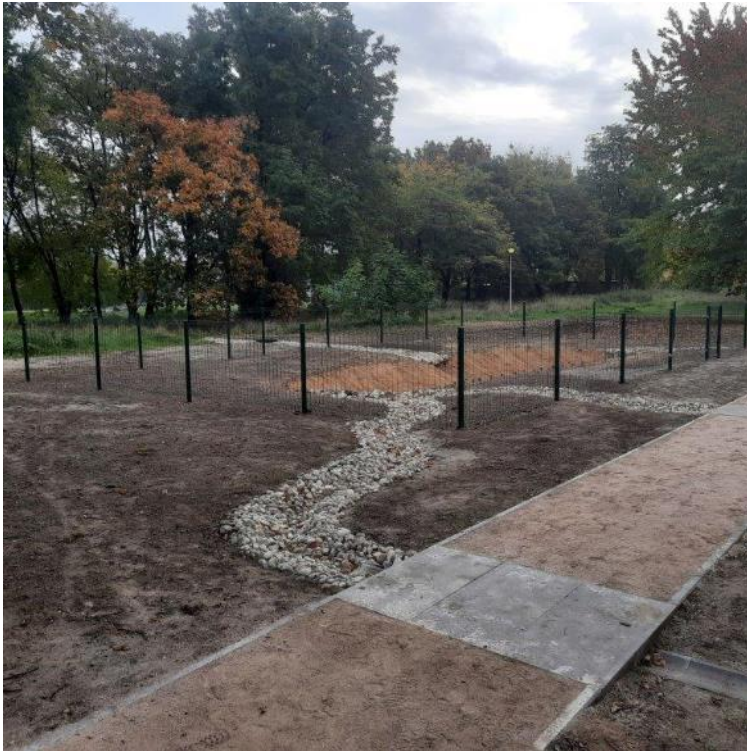
Photo 8 Appearance of the site after construction – Permeable surface

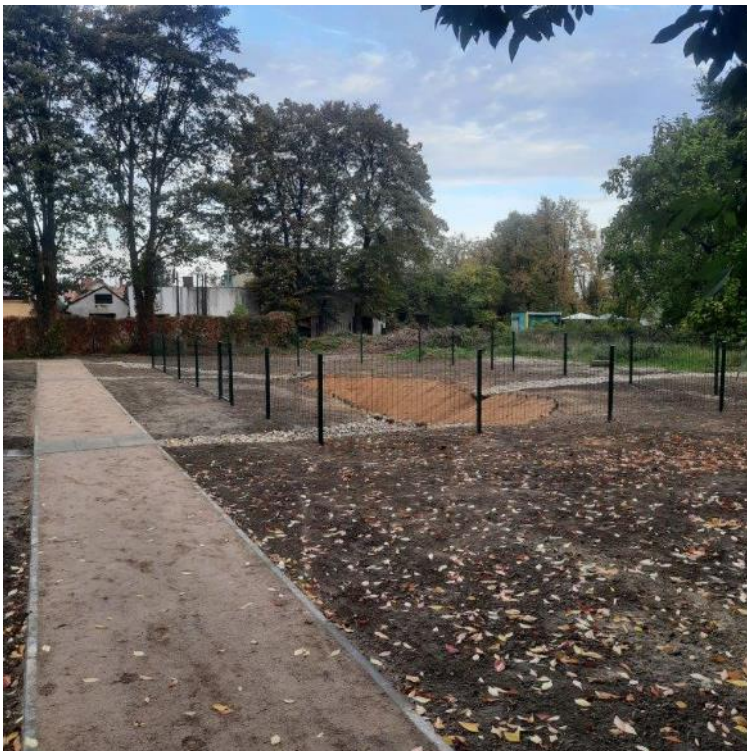
Photo 9 Appearance of the site after construction – Permeable surface

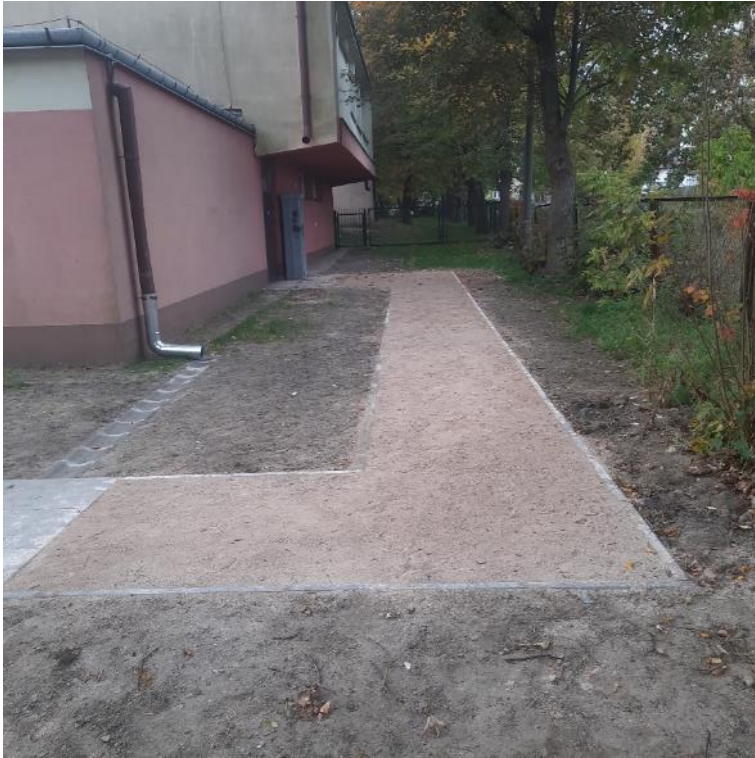
Photo 10 Appearance of the site after construction – Permeable surface
